**Trial of Global Positioning
System Based Field
Wreckage Plotting and
Analysis Equipment Using
Data from a USMC F/A-18
Aircraft Accident**

DSTO-TR-0828

**Airframes and Engines Division
Aeronautical and Maritime Research Laboratory**

On August 20, 1998 a United States Marine Corps F/A-18 aircraft crashed at Delamere bombing range in the Northern Territory. AMRL was invited to aid in the investigation by trialing the AMRL wreckage mapping and analysis equipment at the site. The equipment was used to plot and record all wreckage of interest. Maps of the wreckage were produced on site and handed over to the accident investigation team. These rapidly produced maps, along with the experience brought with the AMRL investigators with on site wreckage examination, greatly aided the accident investigation team to expedite recovery of the site and clarify many aspects of the accident. To this end, the trial of the equipment was very successful. Following this trial, the data was used to explore the capabilities of other visualisation software, and its relevance to accident investigation. The results of this are presented during the discussion of the accident.

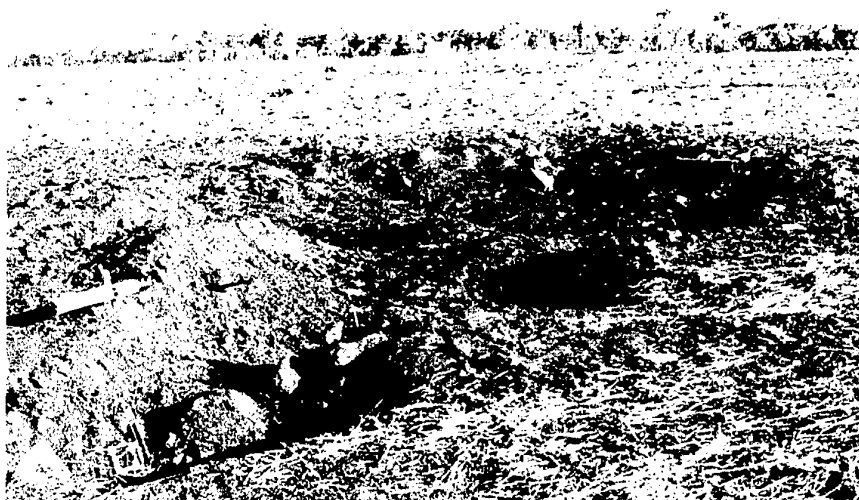
followed by mapping the positions of parts of interest immediately in and around the impact crater. Figure 5 gives an idea of the crater size and the nature of the surrounding range. The raked part of the range was devoid of trees and scrub. Beyond the raked boundary, the vegetation was mainly low trees with open grassed areas, shrubs and numerous termite mounds. Many practice bombs and other ordnance from previous missions were scattered throughout the wooded areas close to the raked part of the range.

Figure 5. The impact crater and the surrounding range. In the distance can be seen the edge of the raked range beyond which the indigenous vegetation existed (trees with an average height of 4m, and scrub) and anthills.

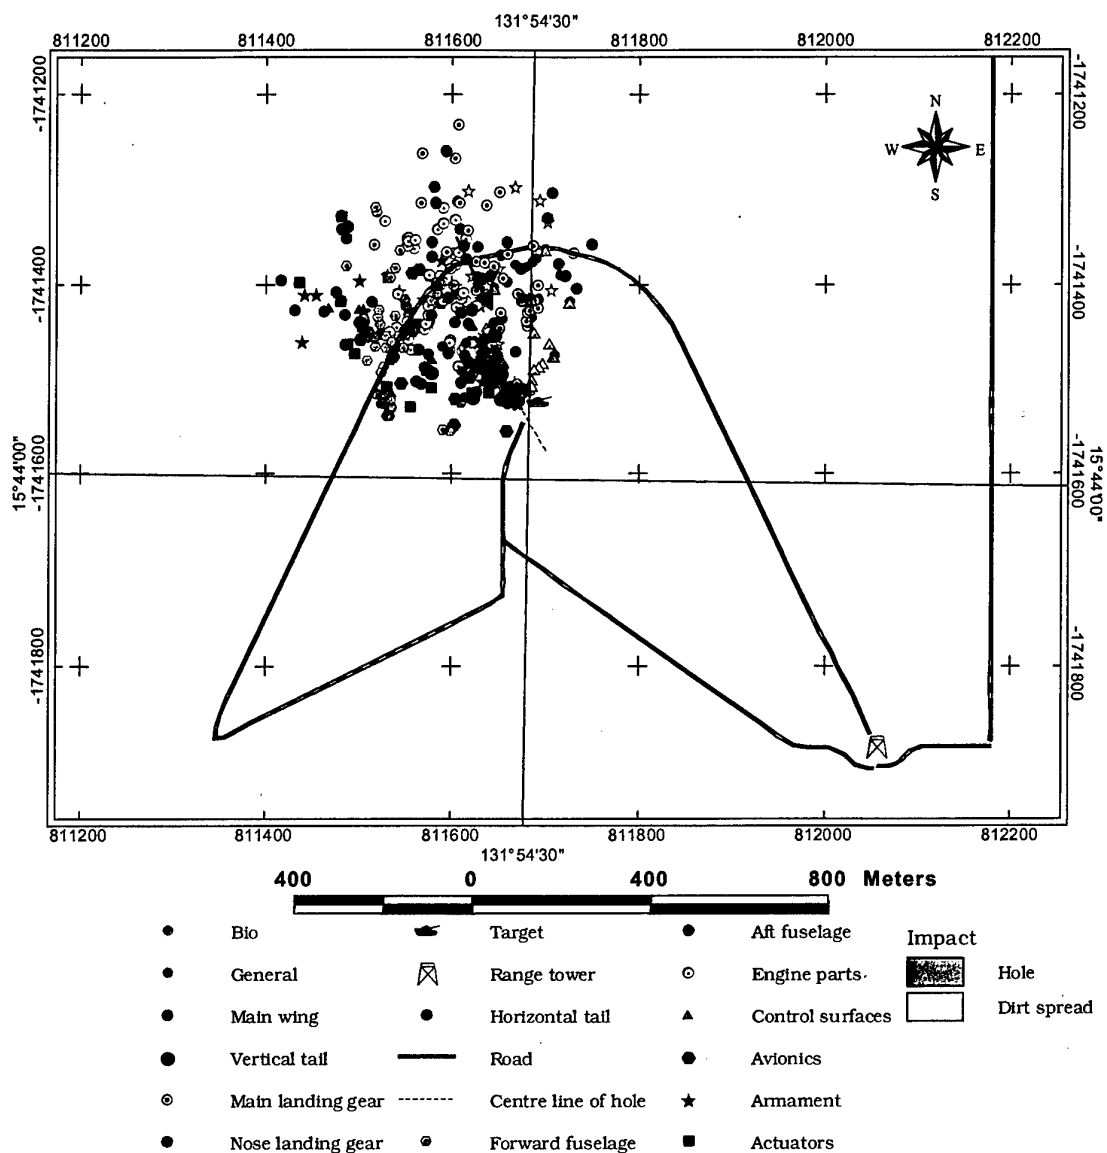
A map and legend of the wreckage site with all the mapped items shown, is presented in Figure 7. A list of the mapped items may be found in Appendix A. The map in Figure 7 indicates that the bulk of the wreckage was spread to the north west of the impact point, and that wreckage was spread over an area of about 600x600m (36 hectares). Some small heavy items were projected beyond these bounds. These were not considered significant enough to be mapped. A search back along the flight path did not find any debris that could have departed the aircraft prior to the impact.

Figure 7 Basic map of the wreckage and the surrounding land marks.

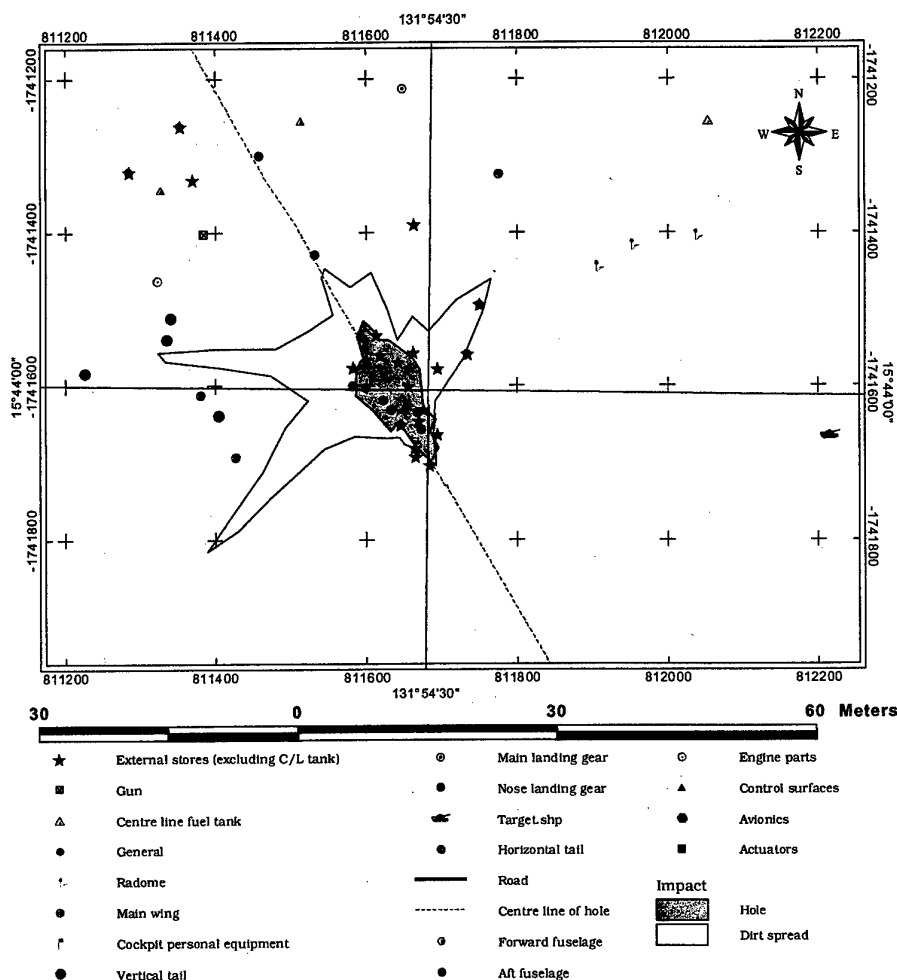
A map of the impact crater is shown in Figure 8. The impact crater was elongated in the suspected direction of the aircraft's travel. The crater was about 17.8 metres long and about 7.9 m wide at its widest point. The widest point was about 10 m from the southern end of the hole. A wing tip launcher - LAU rail part was found embedded in the ground at the southern end of the crater. Other related parts were found nearby, along with a number of wing (side unknown) parts. The ground consists of a layer of compacted topsoil overlaying a local rock known as 'coffee rock'. This rock consisted of hard ball shaped stones embedded in a softer matrix. The crater was a little over 1.5 metres deep, and had penetrated into the coffee rock layer. Very little of the wreckage was present in this crater. After mapping the crater and surrounding material of interest, the crater was further excavated to reveal any buried wreckage. This excavation failed to uncover any further major wreckage items, indicating that the majority of the wreckage had been ejected from the hole during the impact.

Figure 8 Basic map of the impact crater showing the crater shape and the shape of the dirt thrown out by the impact

- Parts of a wing tip missile and launcher were found at the southern most end of the impact crater (the leading end of the crater) indicating that the end of one of the wing tips probably impacted at this point (see Figure 8).

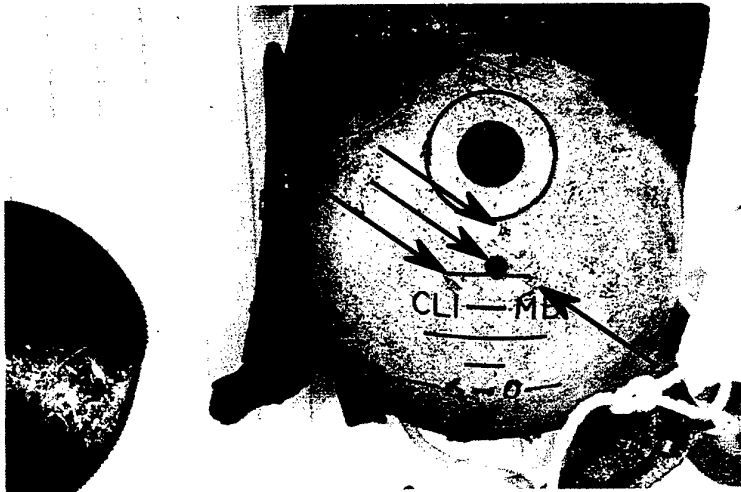
Marks from the rear pitch drive gear and its drive shaft were evident on the ADI ball. The drive shaft had punched a hole in the ball on the 80° CLIMB bar. The drive shaft, which is aligned with the longitudinal axis of the instrument, normally sits in the centre of the drive gear. This means that the hole it created in the ball was diametrically opposite to the pitch reading on the front face of the instrument. Since the scale on the ball is non linear with respect to degrees of ball rotation and reads from 0-90° climb and 0-90° descend, while using 135° of the ball rotation for each (climb and descend), then a hole at the 90° mark on the back of the ball corresponds to a reading of 30° on the front of the ball. Therefore, the hole at 80° climb on the back of the ball suggests that the ADI reading at the time of impact was 40° aircraft centre-line to the ground. The cursory examination of the remains of this instrument did not give a roll angle.

Figure 9 The ADI ball found in the field showing the hole (red arrow) punctured by the drive shaft. The three black arrows indicate indentations caused by the three screw heads adjacent to the drive shaft.

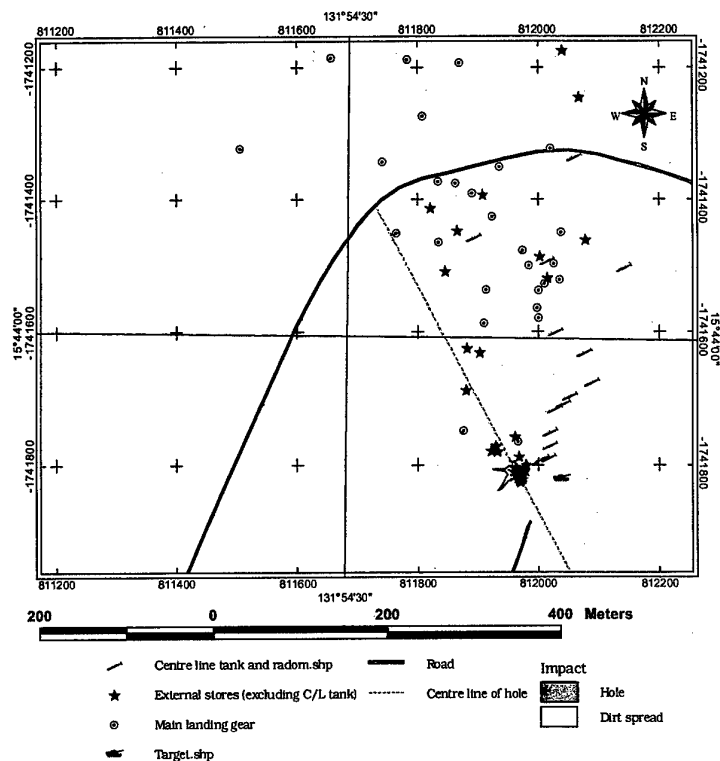
Figure 12 The underbody stores, including the centre-line fuel tank and the main wheels were all deflected to the north of the expected direction of aircraft travel.

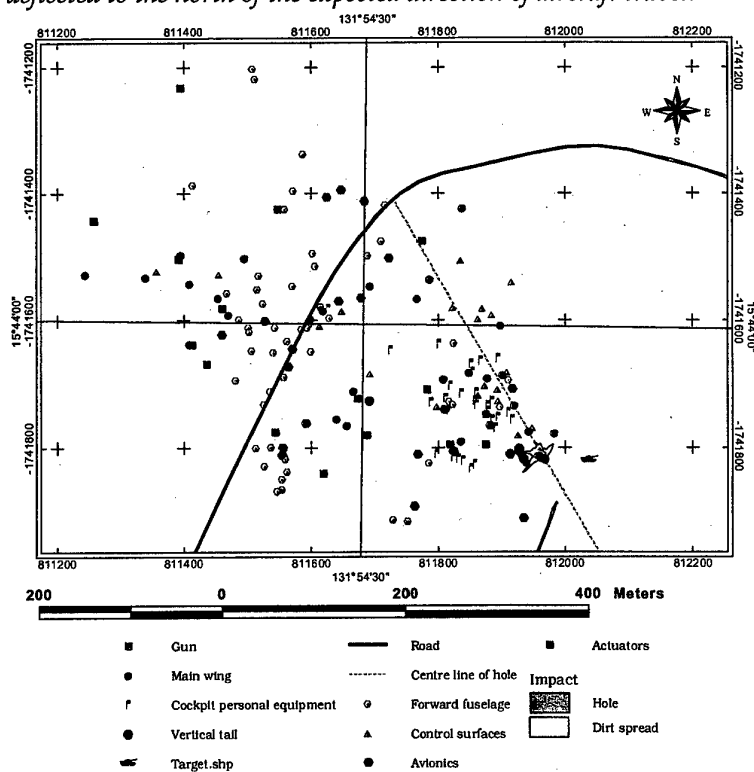
Figure 13 The wings, forward fuselage, gun, cockpit items, actuators, avionics and tail parts were all deflected to the west of the expected direction of aircraft travel.

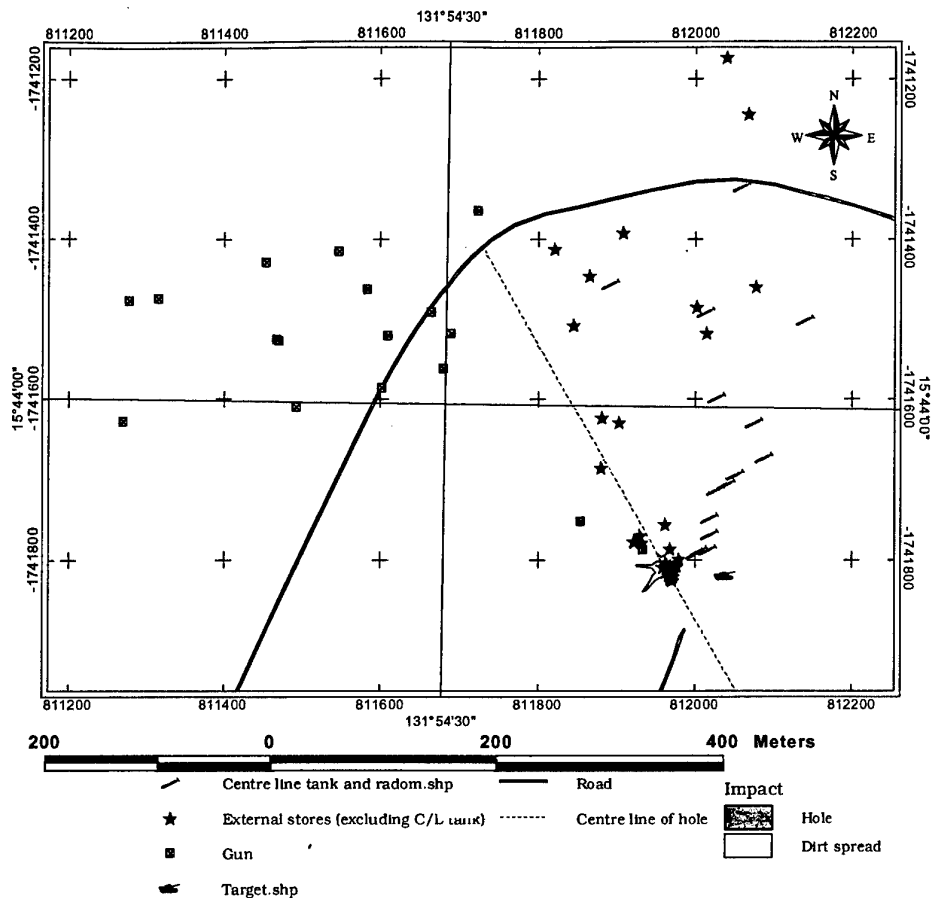
Figure 14 The gun, external stores and centre line tank showing the deflection of these heavy items to either side of the impact crater.

The cause of the deflection of items to either side is probably the result of two significant factors;

- (a) The aircraft was banked to the left, and
- (b) the engines, after impact travelled through the aircraft in approximately a straight line, deflecting items of the aircraft to either side.

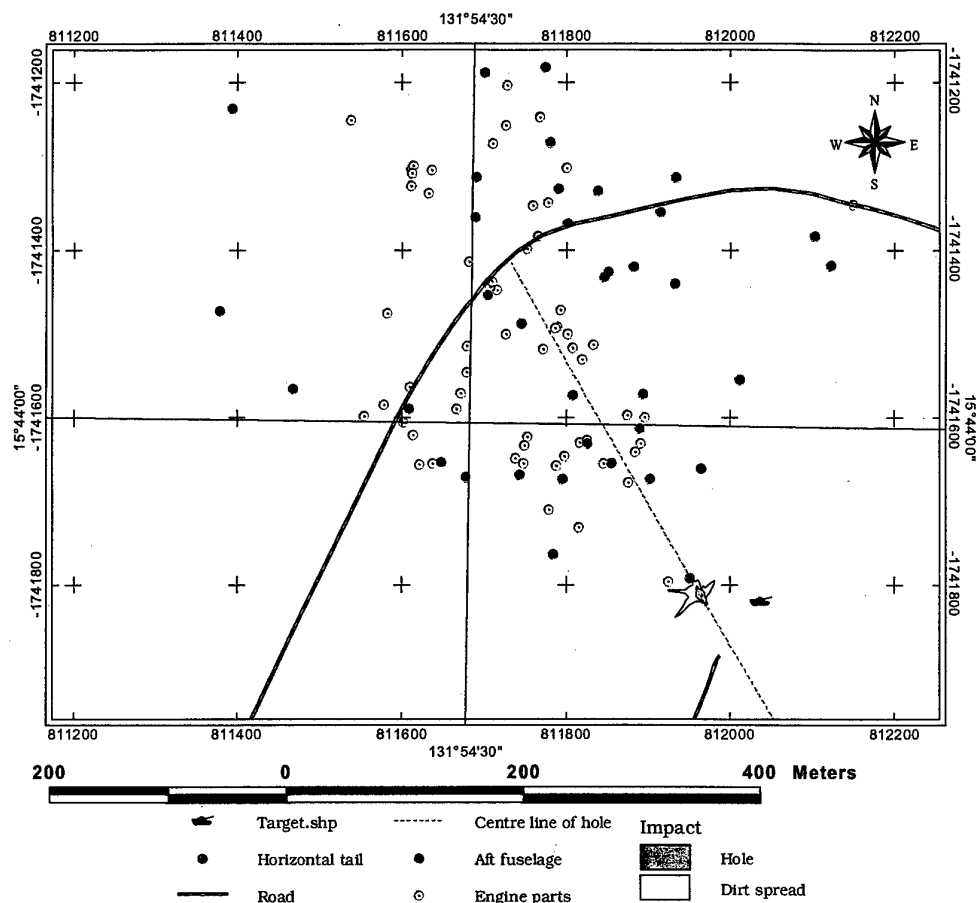
Taking the second point first: An examination of the positions of the engine parts indicated that they had mostly travelled in the approximate line of aircraft travel, Figure 15. As would be expected the high mass of the engines, along with their aft placement would probably result in these parts having the least deflection from the aircraft's heading at impact. The very highly disrupted nature of the airframe in this accident also suggests that the engines travelled through the structure. The, relatively narrow width of the impact crater suggests a low angle of attack with wings vertical. These facts are supported by the observed nature of the crushing of the centre-line fuel tank, which appeared to have been crushed along its axis. Had an angle of attack been present the crushing of the centre-line tank would have been along an axis offset by the angle of attack.

Figure 15 A map showing the engine parts, aft fuselage parts and the horizontal stabiliser parts. Note that all these parts appear to be clustered along the probable direction of aircraft travel at impact.

A further examination of the items mapped in Figure 15 indicates that apart from the engines and aft fuselage parts travelling along the extended centre-line of the hole, indicating the axis of travel of the aircraft at impact, the horizontal tail also appears to be along this line. This would suggest that the tail was not generating either lift or down force at the time of impact. Either of these would have been expected to deflect the aerofoils to one or the other side of the direction of travel of the aircraft – remembering that the aircraft appears to be banked at about 90 degrees to the left. This also supports the notion that the aircraft was not pulling positive angle of attack at impact. This should be compared with the wings, which were probably generating some lift resulting in deflection to the west of the crater. The vertical tails would have been on its side to the left in this scenario, and therefore should be to the west side of the crater, as they were. The actuators were also spread to the west of the centre-line also, along with the control surfaces, as these are mostly associated with the wings. These features are shown in Figure 16.

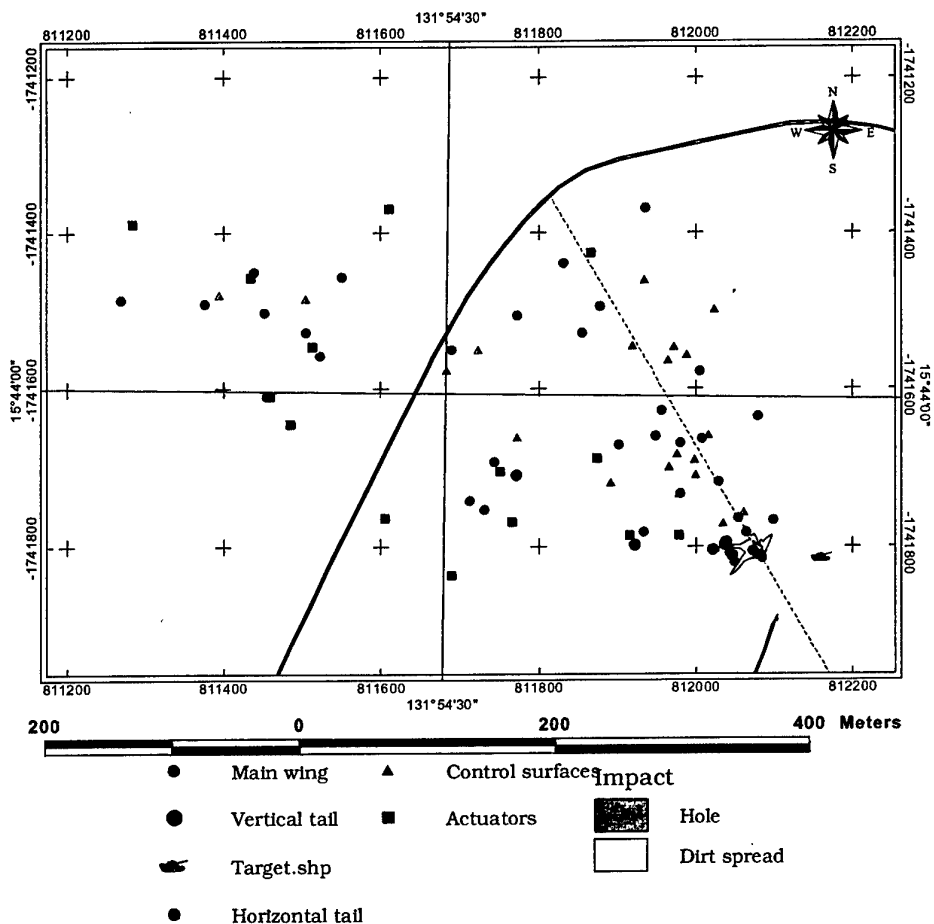
Figure 16 The positions of the lifting surfaces and associated parts indicating that the horizontal tail did not appear to be generating lift or down force at impact.

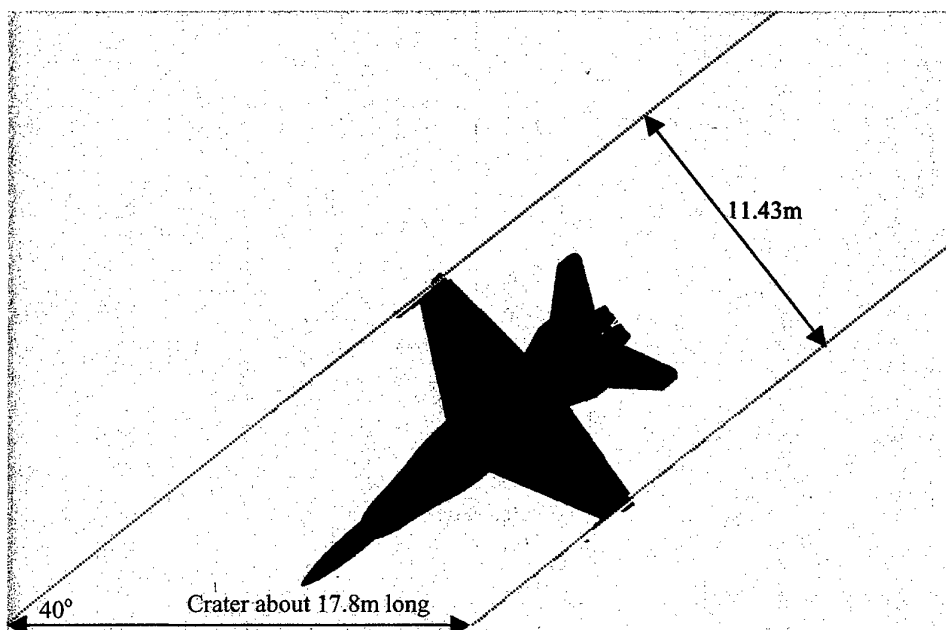
The spread of the wreckage suggested that the main momentum vector ie the direction in which the aircraft was travelling was roughly north west, and aligned with the centre-line of the impact crater. If the aircraft had impacted wings level the crater would have been of the form of a silhouette of the aircraft. Typically with wing impressions either side of the hole and an elongation of the hole depending on the angle of attack of the aircraft, the direction of travel of the aircraft and angle of the aircraft to the ground. Clearly the crater was not of this form. The analysis of the positions of certain wreckage items strongly indicated that the aircraft was steeply banked to the left at impact (probably about 90°). The lack of wing impressions to the side supports this. With the aircraft banked by about 90 degrees to the left at impact, the length dimension of the hole takes on the wing form. If the width of the aircraft is considered along with the length of the hole, a calculation of the angle at which the aircraft struck the ground can be made. The geometry of this situation is shown in Figure 17. Knowing that the aircraft was 11.43m wide and the crater was about 17.8m long, and assuming that the entire length of the crater was caused as a result of the wing tip to wing tip dimension, the aircraft impact will be a reflection of the aircraft projected onto the ground from its direction of travel. Calculating this projection gives an angle that the aircraft would have made with the ground of about 40 degrees. This is supported by the evidence of aircraft attitude as suggested by the examination of the ADI.

Figure 17. A projection of the aircraft onto the ground at about 40° gives the approximate length of the impact crater.

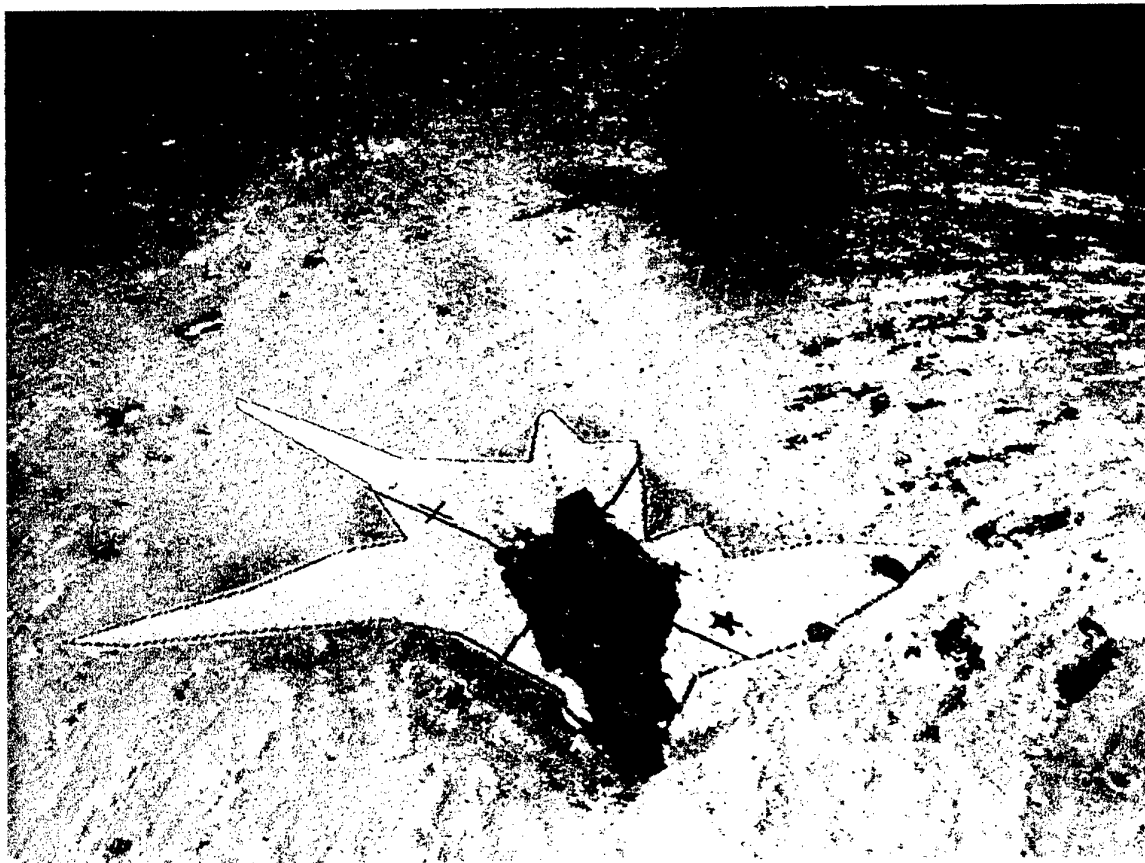
Figure 18 A view of the impact crater from about 50m above the raked range from roughly along the flight path of the aircraft. A projection of the map of the impact crater and dirt spread has been placed over the image of the crater.

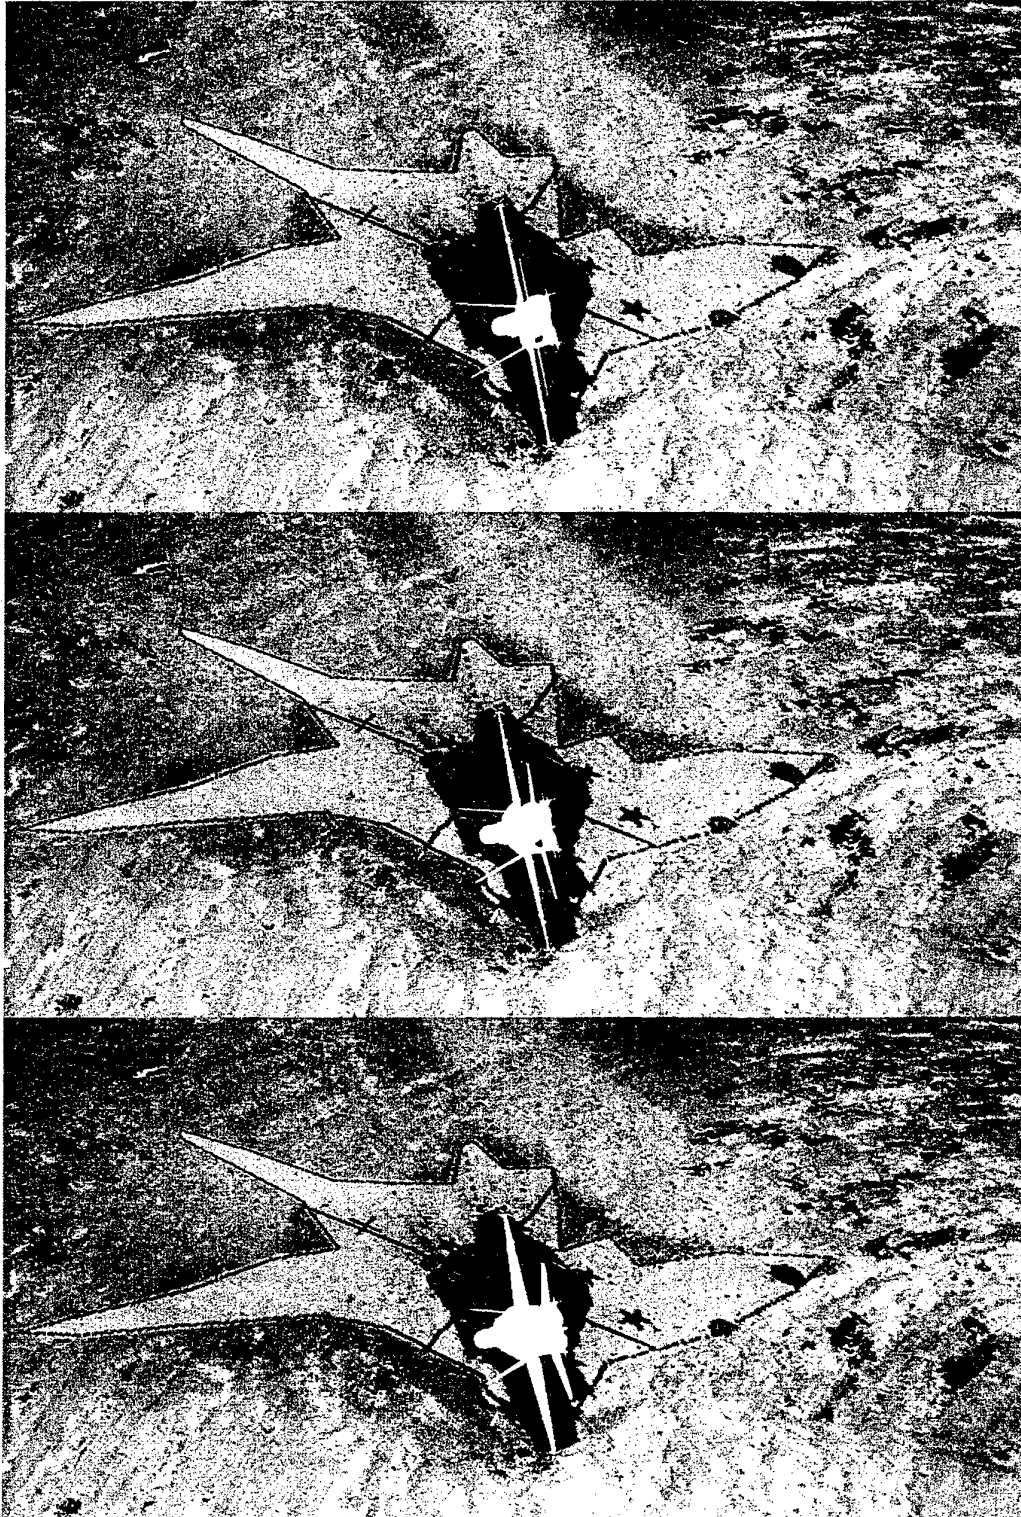
By adding a 3D model of the F/A-18 aircraft to the image shown in Figure 18, and placing the model in the suspected orientation over the hole, it was possible to determine whether the hole was consistent with the hypothesis. It is also possible to try different angles of attack to see if the projection of the aircraft is consistent with the impact crater. Three of these projections are shown in Figure 19. Although angles of attack from 0-10° appear to be possible, the ejecting debris could easily have widened the crater. This argument is not as strong when considering crater lengthening due to debris ejection. The main mass of the aircraft would have impacted the ground about the centre of the crater, resulting in widening to either side and towards the far wing tip. Since the impression made by the far wing tip is about 9m from the centre of the aircraft impact, there is considerable distance for crater lengthening without reaching the wing tip mark. Assuming perfect reflection, (ie. 40° in and 40° out of a 2m deep hole caused by a 2.5m (approx.) wide fuselage, then the widened part of the hole would be about 7.5m long). Naturally, the material exiting the crater would be wider, due to fuselage spreading, than the fuselage entering the hole and therefore the hole would be expected to be wider on the exit side. These points are consistent with the approximate length of the wide section of the crater, which is about 8.5m long, with the wider section of the hole being biased towards the furthest end.

Figure 19 Three views of a projection of an F/A-18 on to the map and image of the impact hole. The first view is with the aircraft at a 0° angle of attack, the second at 5° angle of attack and the third at 10° angle of attack. Although all are possible the ejecting debris could easily have widened the crater.
